# Inspection Report

## Sample Report

**Property Address:**  
1st Sample Street  
Anywhere NY

**Capital District Home Inspectors**

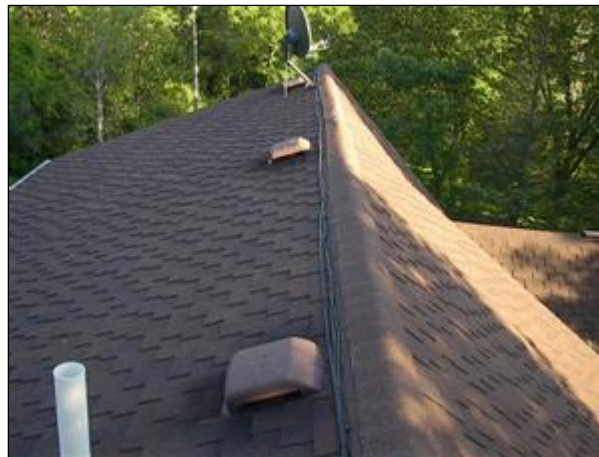
1.0 Picture 1

(1) Asphalt architectural shingles noted appear in serviceable condition.

Two roof vents, no ridge vent observed. (Picture 1)

I suggest requesting manuals and/or warranties from current homeowner.

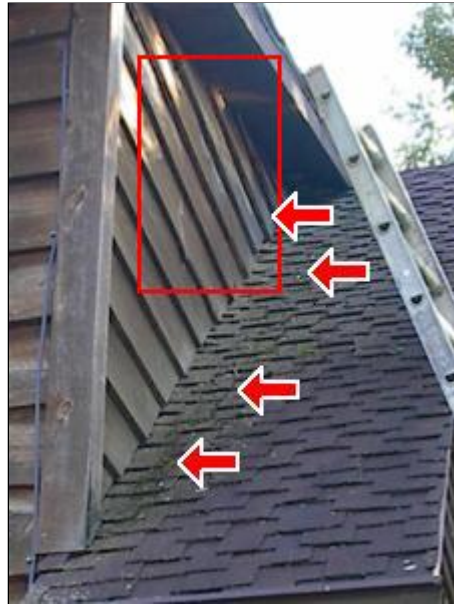
1.0 Picture 2

(2) (Picture 2) Shingles at this location northeast rear of home have active moss growth suggesting moisture. Recommend evaluation by professional roofer and/or exterminator for presence of active mold and active wood boring insects.

Recommend minimum of four siding boards be removed for thorough inspection for wood boring insects and/or structural damage and repaired as needed by qualified professional.

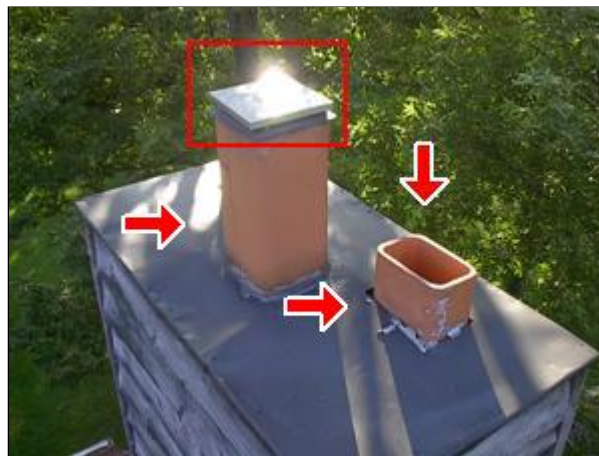
1.2 Picture 1

Noted cracks in tall flue pipe (noted by rectangle) to fireplace.

Voids in metal observed at this location on roof (noted by arrows). Moisture penetrating through cracks to basement area at right of furnace north side of home. (Picture 1)

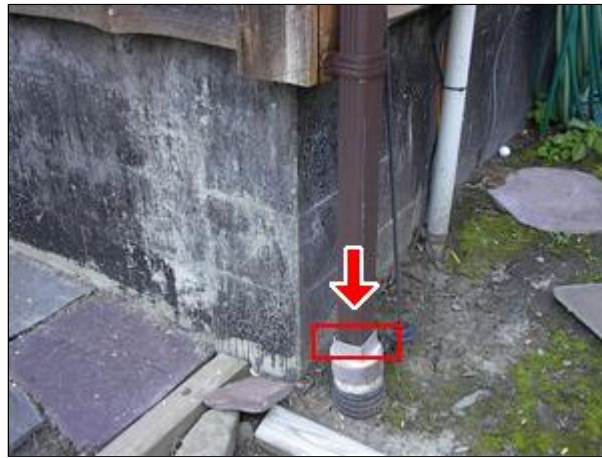
1.3 Picture 1

(1) The gutters appear intact but due to the lack of recent rain, I am unable to determine if gutters leak at seams or spills water.

Recommend separating gutter attachment to underground drainage slightly to maintain integrity of drainage system by a qualified person. Southeast front corner of home. Possible freezing of water in downspout could cause ice back up and failure of roof drainage system. (Picture 1)

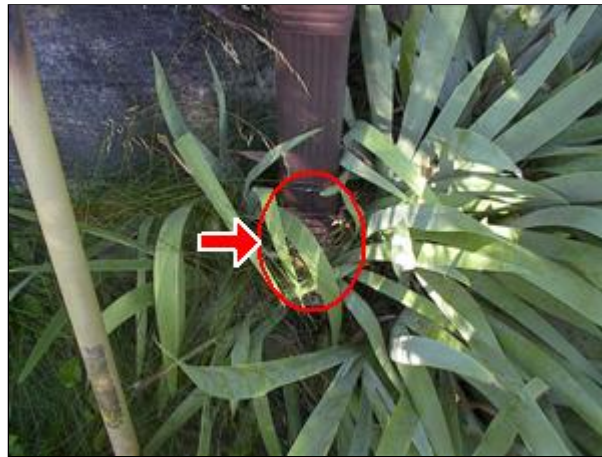
1.3 Picture 2

(2) Downspout located at southwest front corner of home has no extension in place. Recommend buried drain line appropriate for this purpose be installed by qualified person to carry water away from the home.(Picture 2)

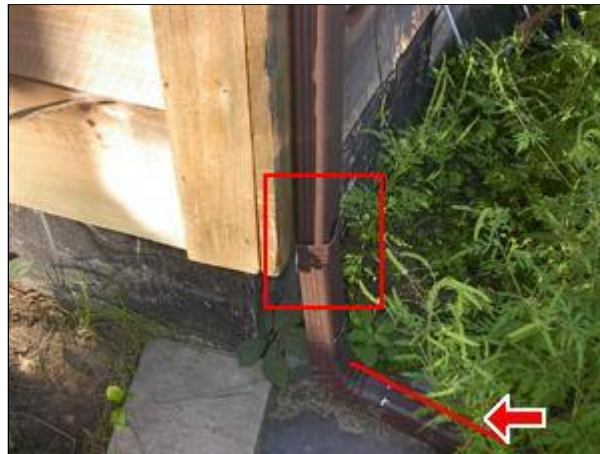
1.3 Picture 3

(3) Downspout extension at this northwest rear corner location appears crushed. Recommend remove existing extension and replace with buried drain line appropriate for this purpose to carry water away from the home by qualified person. (Picture 3)

Recommend reattaching loose gutter strap.

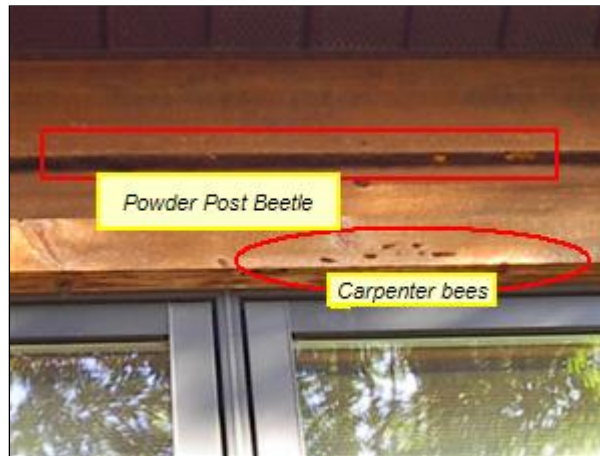
2.0 Picture 1

(1) Rough hued cedar siding noted. Active wood boring powder post beetles and wood boring carpenter bees observed at every exterior siding location. Recommend further evaluation by professional exterminator.

Recommend maintenance for cedar siding to include, but not be limited to, sealing on a regular basis with semi transparent wood stain designed for the purpose by qualified individual.

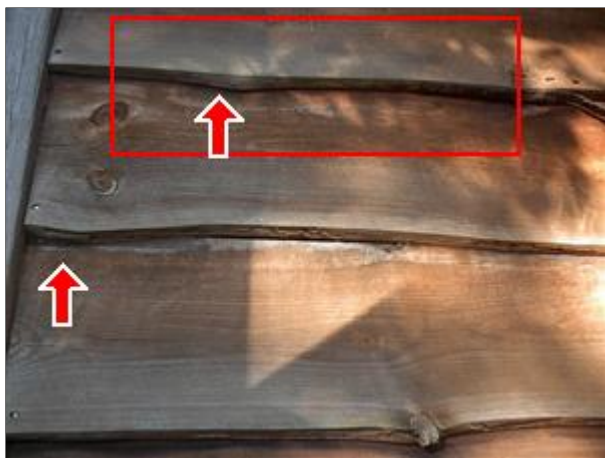
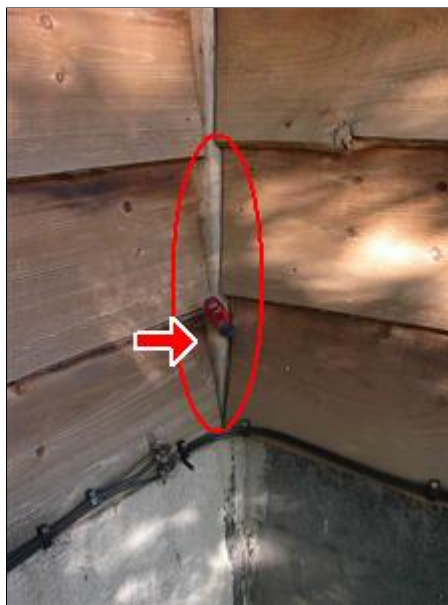
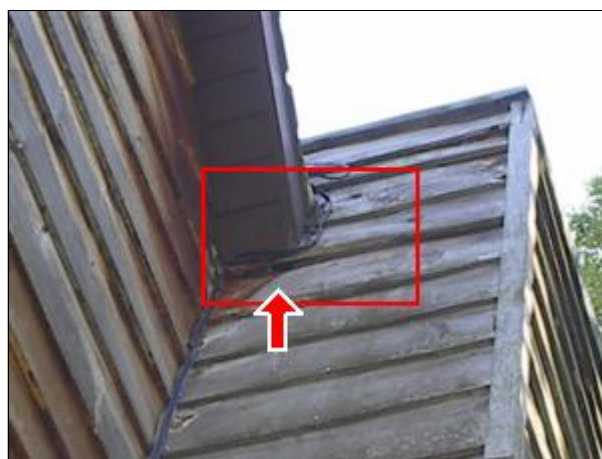
(2) Large voids noted in cedar siding and vapor barrier allowing moisture to penetrate into the structure possibly causing moisture and mold damage. Pictures 2,3&4 show siding surrounding fireplace chimney at north side of home.

All areas of structure that have moisture penetration are prone to wood destroying insects, rot, decay and/or mold and need to be further evaluated by professional contractor and/or technician.

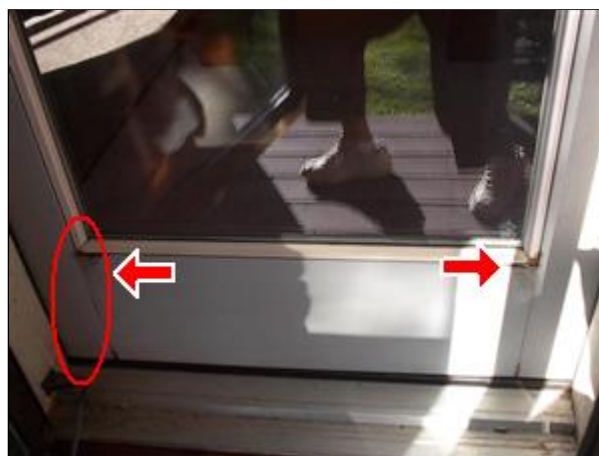
2.1 Picture 1

- 🏠 (1) (Picture 1) Weeping at weather seal observed at exterior steel door west side of home. Recommend application of seal designed for this purpose by qualified person. Prime and paint with products designed for this purpose by qualified individual.

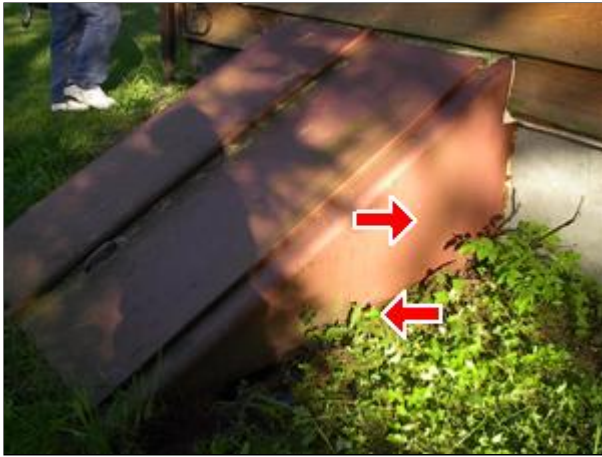
2.1 Picture 3

- 🏠 (3) Bilco door entrance at rear of home is rusted and deteriorated (Picture 3). Standing water noted at interior basement bilco entrance. (Picture 4)

Eroded ground area noted to left exterior of bilco entrance door. Water penetrating this area. (Picture 5). Recommend service by professional bilco installer or qualified contractor.

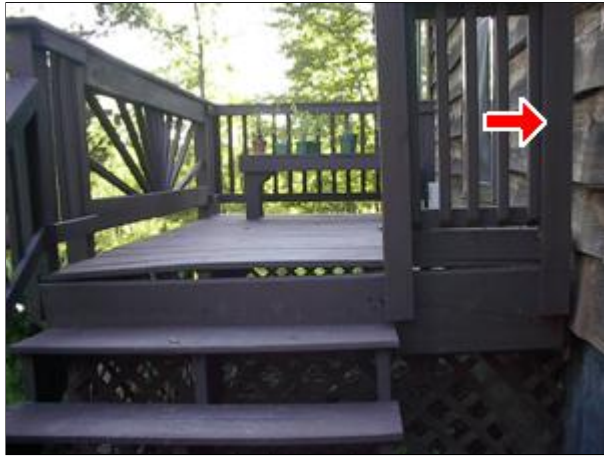
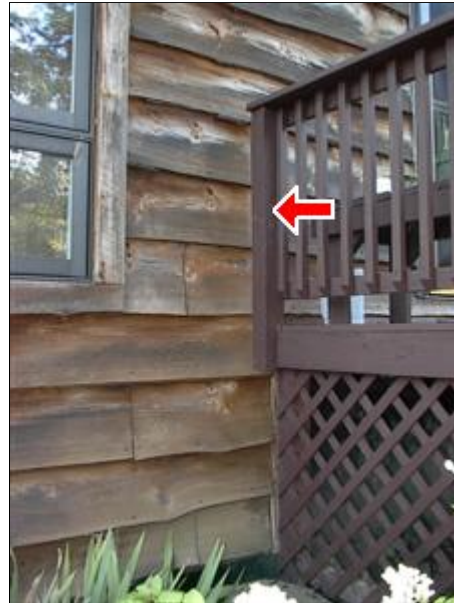
- 🏠 (1) No footings observed at south/driveway side porch location. Recommend securing posts nearest home to siding wall for added support by qualified individual. (Picture 1)(Picture 2)

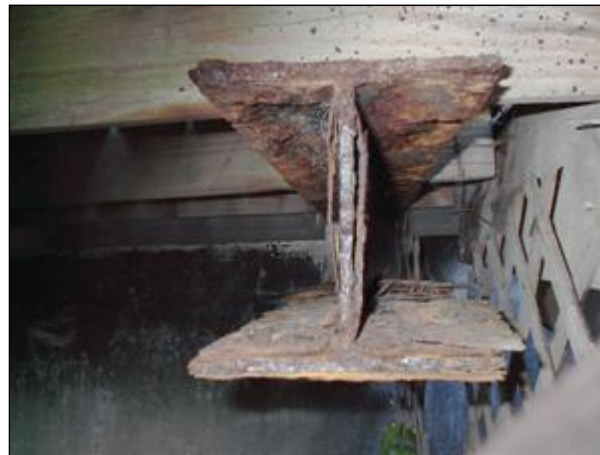
2.3 Picture 3

Steel I-Beam support of porch appears rusted. Recommend scrape, sand, prime and paint regularly to restore and maintain integrity. (Picture 3)

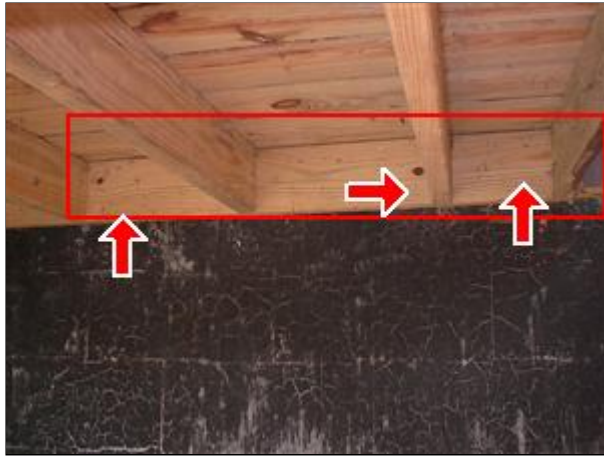
2.3 Picture 4

- 🏠 (2) This porch is located at west side of home. Recommend qualified contractor further evaluate need for additional support where porch attaches to home. (Picture 4)

🏠 (3) #2.3 (Picture 4) shows missing lag screws and hangers.

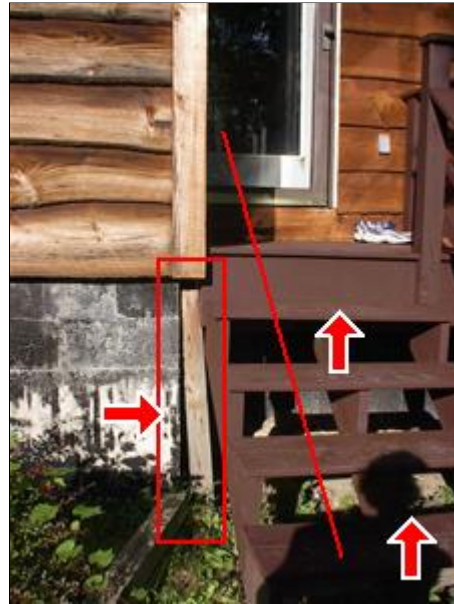
2.3 Picture 5

Left (facing porch) side support post is leaning, left railing is missing and risers are not evenly spaced. (Picture 5) Recommend repair by qualified professional.

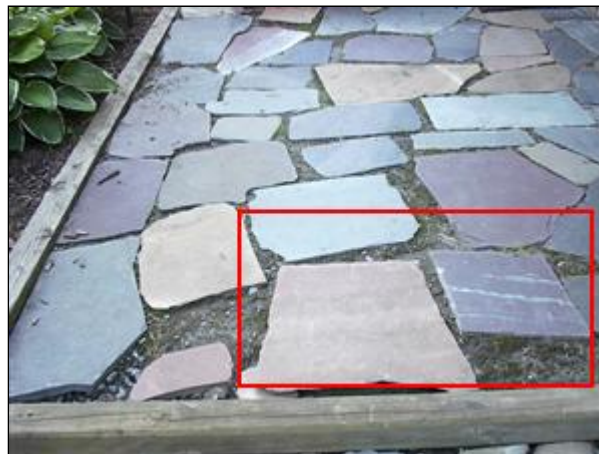
2.4 Picture 1

🏠 (1) Loose patio stone presents tripping hazard. Recommend qualified person evaluate and repair or replace as needed. (Picture 1)

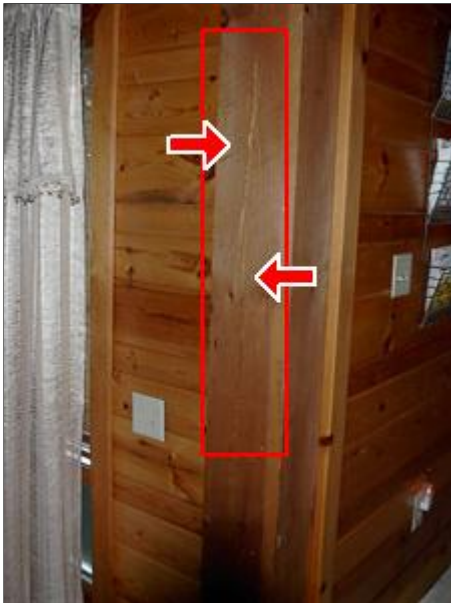
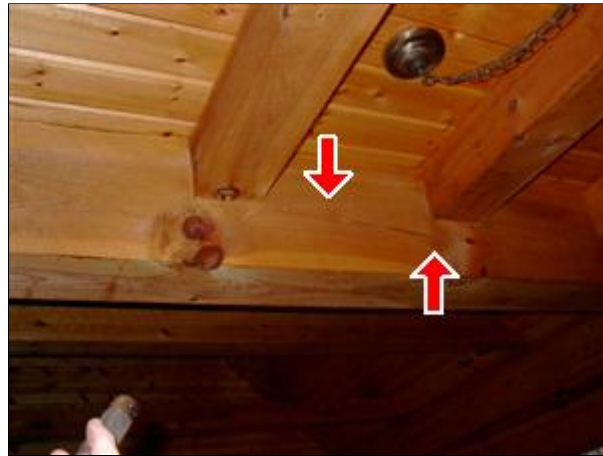
Cracks are apparent in wood supporting beams of home. Recommend further evaluation by qualified professional.

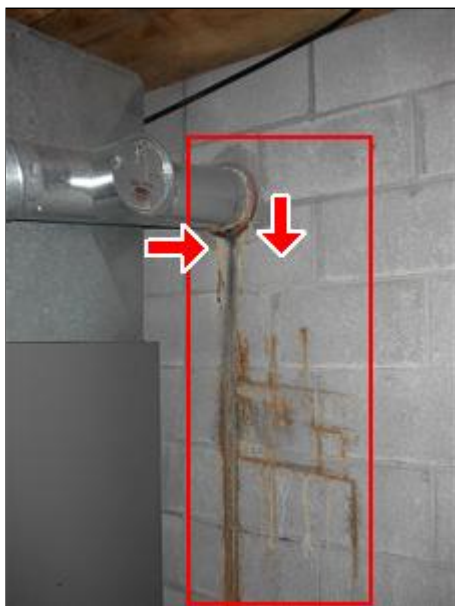
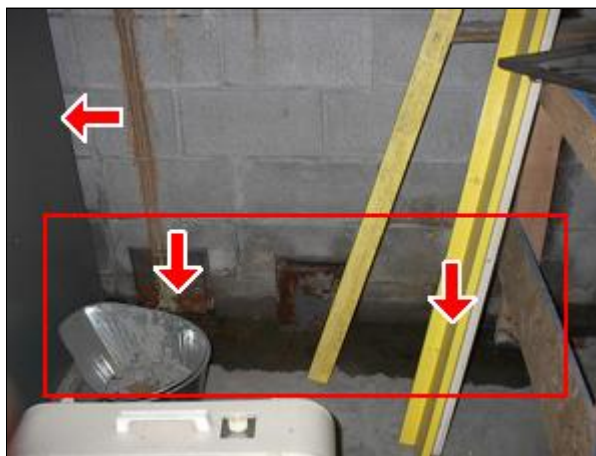
Water infiltration through basement wall with standing water at basement floor in this location to right of furnace north side. (Picture 1&2)

Recommend further evaluation and repair by qualified professional. Recommend evaluation for insects and mold. Insects and mold thrive in these conditions.

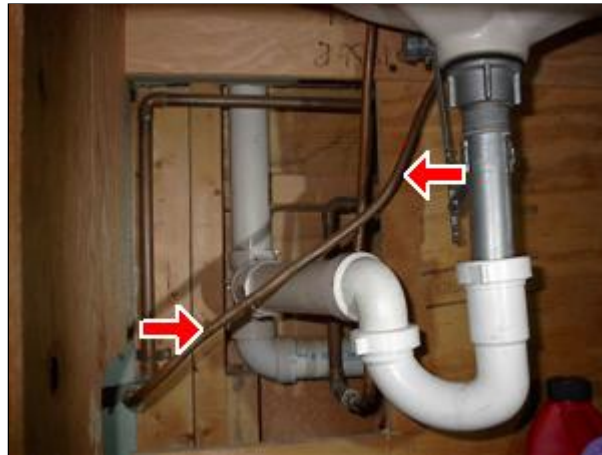
5.1 Picture 2

- 🏠 (2) Soft copper under size water line noted at second floor bath sink. No water shut offs noted. Recommend licensed plumber evaluate further.

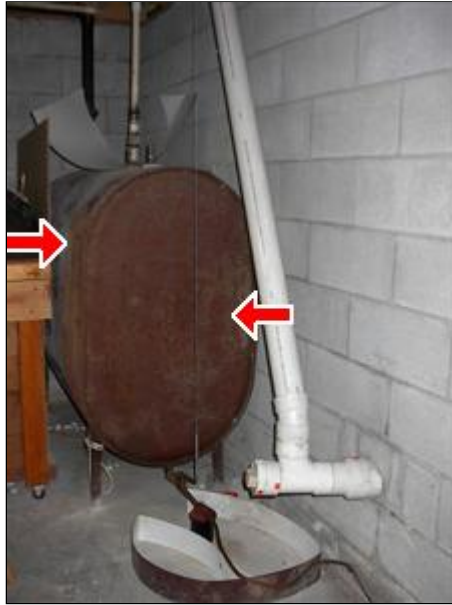
5.4 Picture 1

- 🏠 175 gallon gravity fed oil tank observed at west rear side of basement appears to contain approximately three-eighths of a tank of heating fuel. Noted oil line encased in conduit to furnace. Filter noted. Rust observed. Unit appears serviceable. (Picture 1)

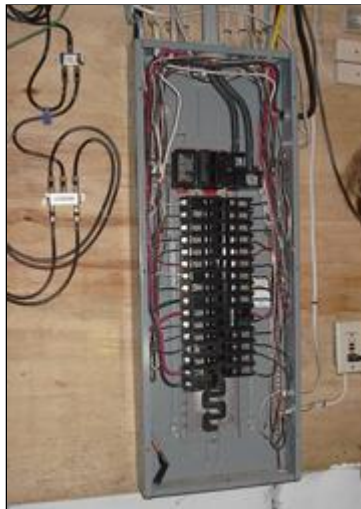
6.1 Picture 2

- 🏠 (2) Vacant areas noted in Challenger brand breaker box as well as empty breaker. (Picture 2)

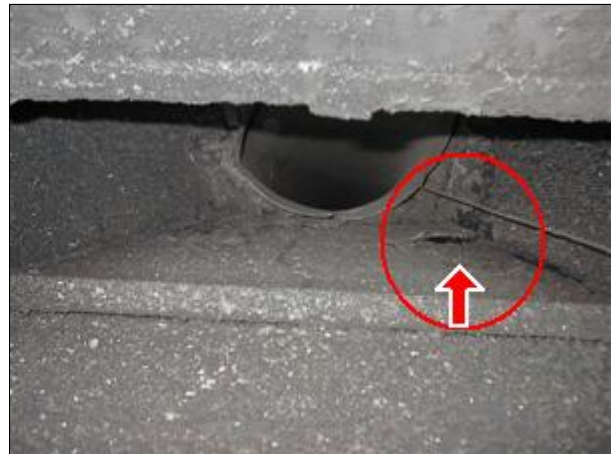
7.6 Picture 2

I recommend chimney and wood burning fireplace serviced and cleaned prior to use each season by professional chimney sweep. (Picture 1) Crack noted at clay chimney liner. (Picture 2)

Recommend fireplace not be used prior to thorough evaluation by qualified professional.

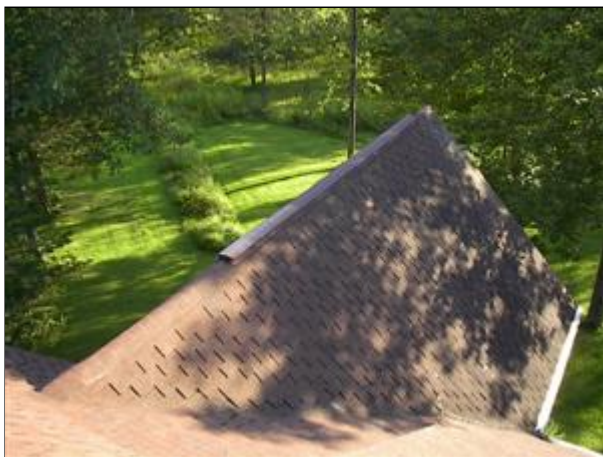
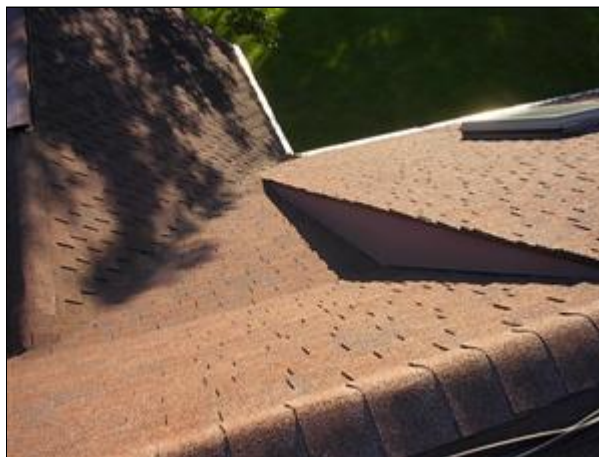
🏠 (1) Roof vents and soffit vents noted. No ridge or gable vents observed. Recommend professional roofer evaluate. (Picture 1)(Picture 2)
